THE ENERGY REGULATORY COMMISSION VS.) CASE NO.
THE UNION LIGHT, HEAT AND POWER COMPANY) 8133

REPORT
OF
INVESTIGATION
AT
SIMON KENTON HIGH SCHOOL
CONCERNING
NATURAL GAS EXPLOSIONS AND FIRE
ON
OCTOBER 9, 1980

January 20, 1981

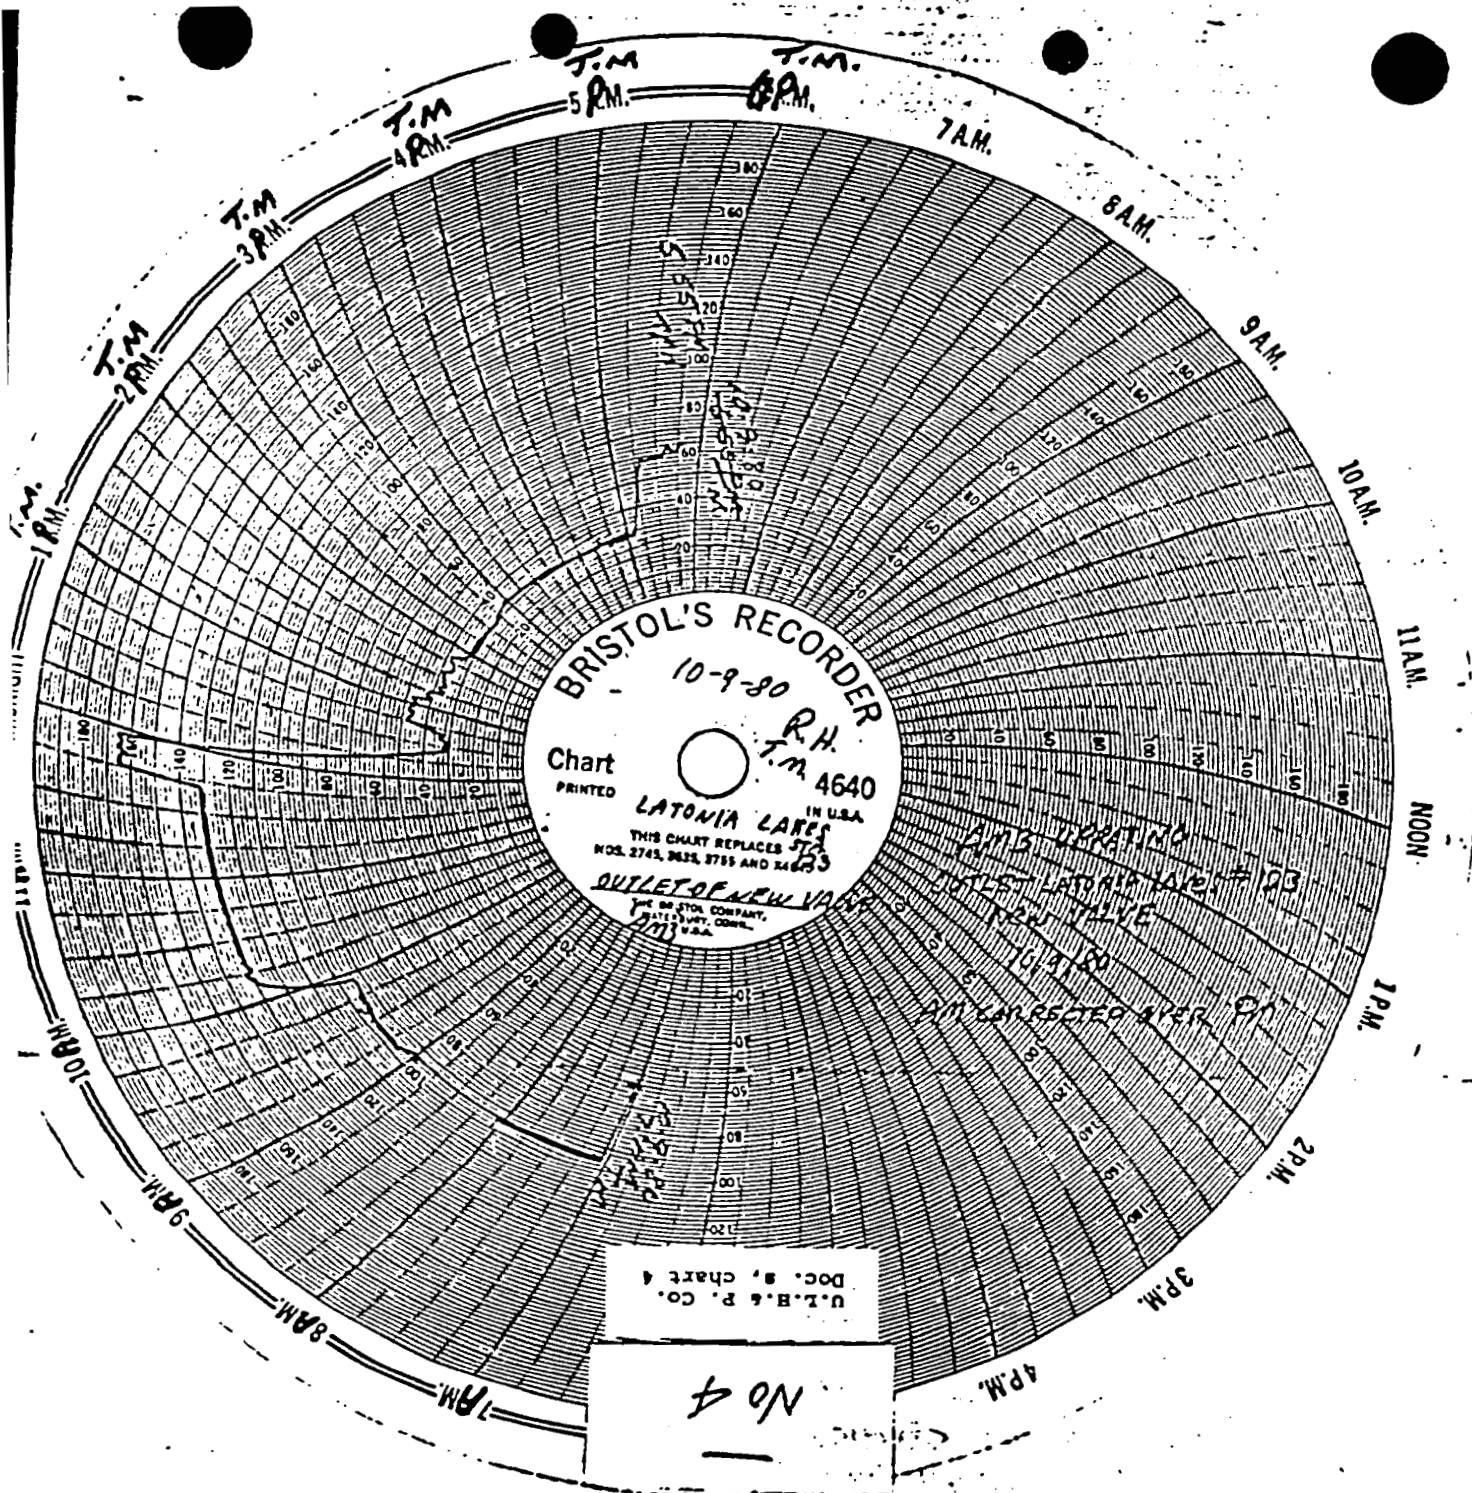
LATONA LAKES STATION #123
BEGINNING OF UPRATE SECTION

Phase II involved the uprating of 11 miles of 4 inch transmission or "feeder" pipeline downstream of the Phase I line, to be done in four steps, or from 60 to 95 to 130 to 165 to 200 PSIG. (See copy of pressure chart located on outlet side of throttling valve at Latonia Lakes Station)

THE CHART WAS MANUALLY
ADVANCED ONE HOUR FROM
700 AM TO 800 AM BECAUSE THE
HUB WAS NOT TIGHT AND IT
DID NOT MOVE DURING THE
FIRST HOUR TMH

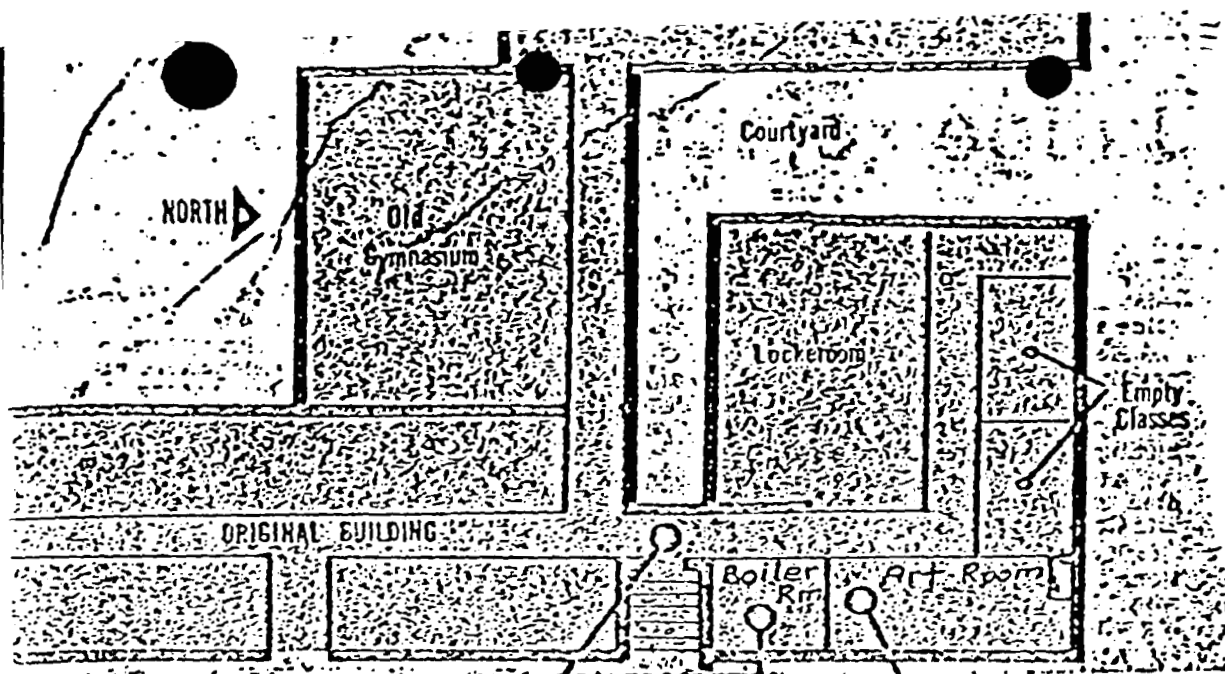
1" = 40' - 12/15/80 - ELL
Gas Service Connection
Simon Kenton High School
Served by Union Lt. Ht. & P.

1. Union's employees were not aware of the fact that the high school's service line was connected directly into the 4 inch transmission line being uprated. (See Photographs 8 and 9, also copy of U.L.H.&P. News Release dated October 10, 1980) Apparently this connection was not recorded on Union's maps, as required by 807 KAR 50:015 Section 17(1)(d).

program who were uprating transmission lines AM-3 and UL-7 to know that the three (3) inch service line was connected to the four (4) inch transmission line instead of the two (2) inch distribution line. (Both lines were located in the same ditch, at this particular location, approximately twelve (12) inches separating the lines.)

Center of Second Explosion

3" Gas Service Line
